Machine Used: TensileTurn – Industrial Upgrade Model

Machined Specimens:

Machining Conditions:

Turning Operations:

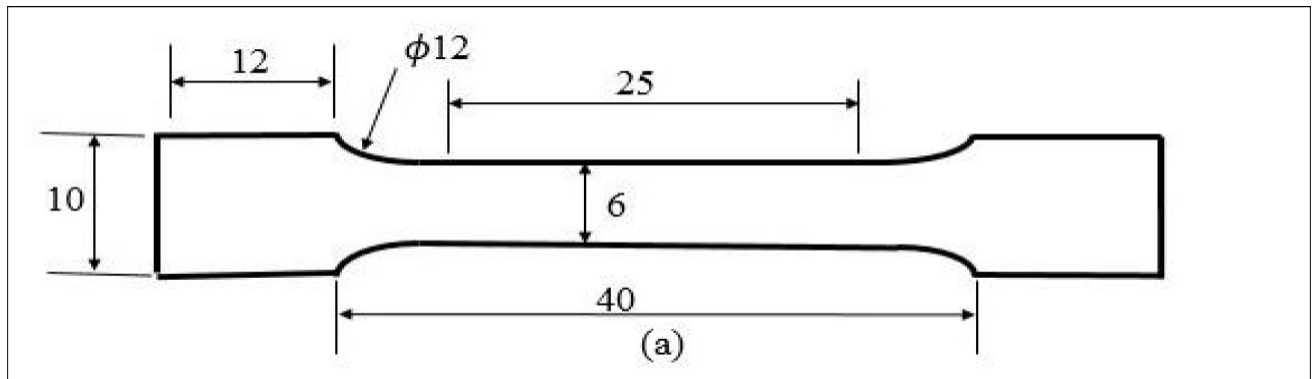
ASTM E8 Schematic Representation

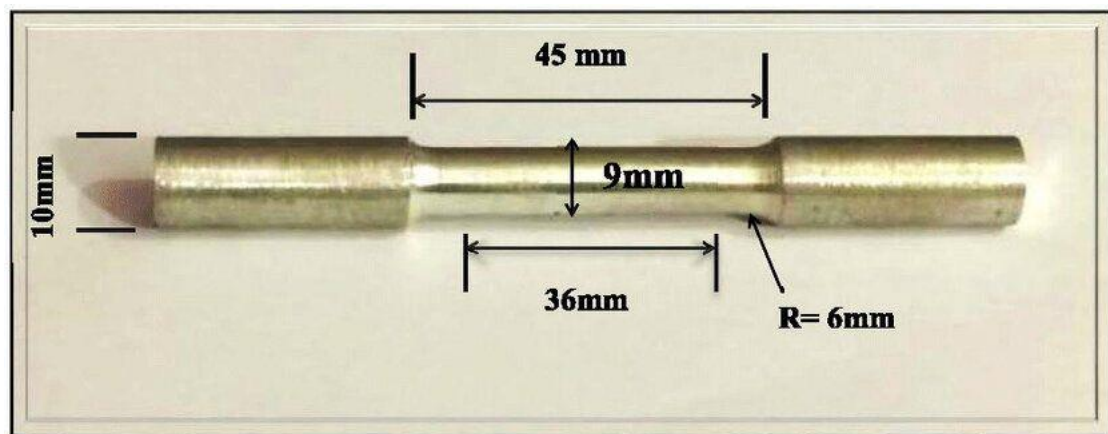
ASTM E8 Test Sample – Dimensional Reference

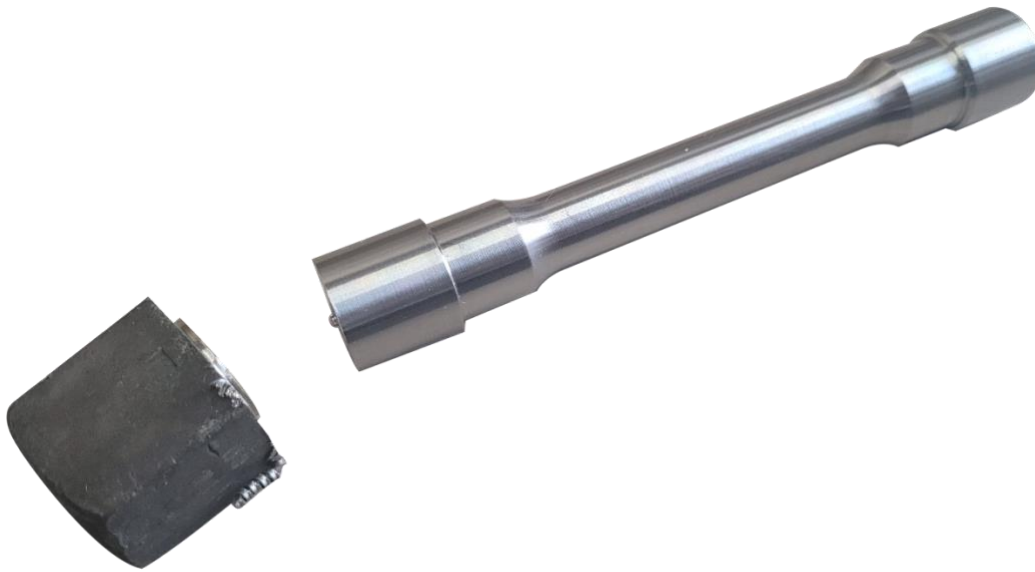
C276 UNS N10276 – 90 HRB

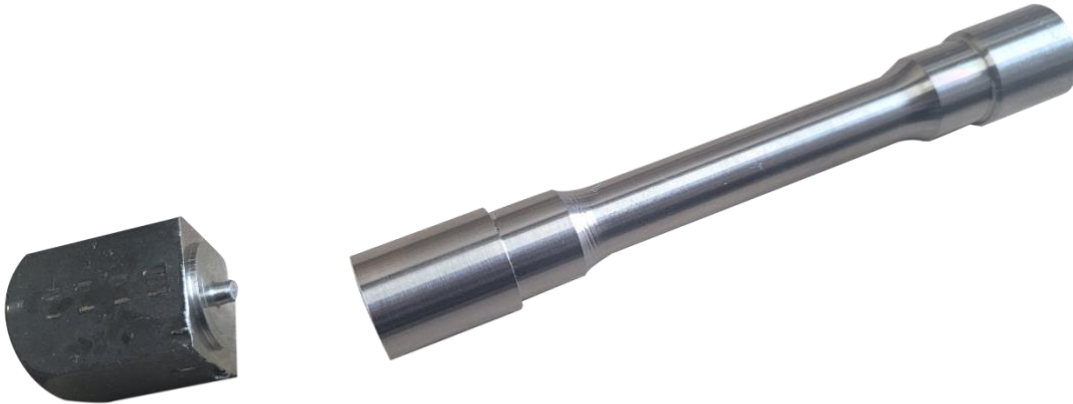
A625 UNS N06625 – 98 HRB

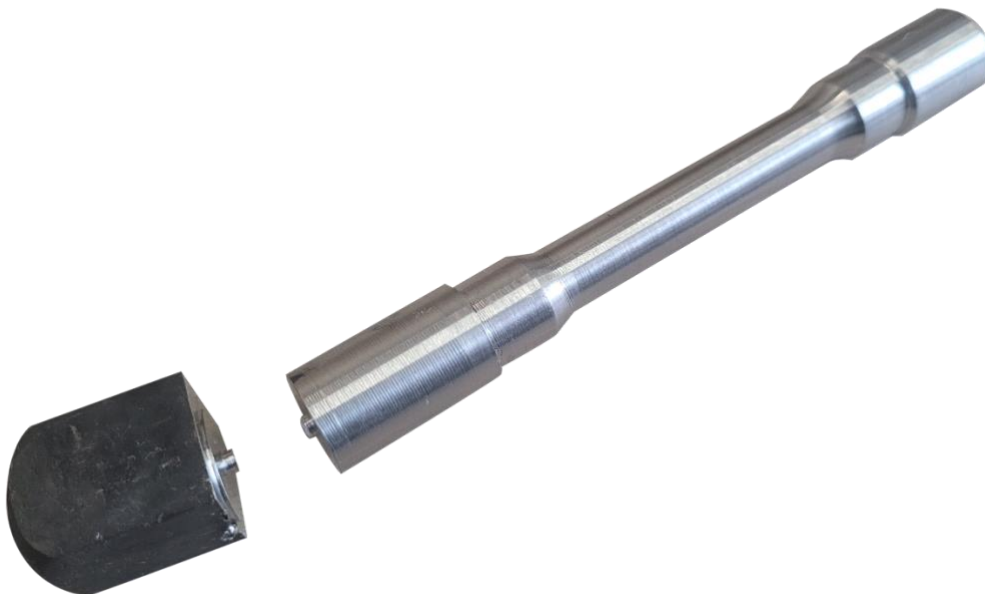
A600 UNS N06600 – 88 HRB

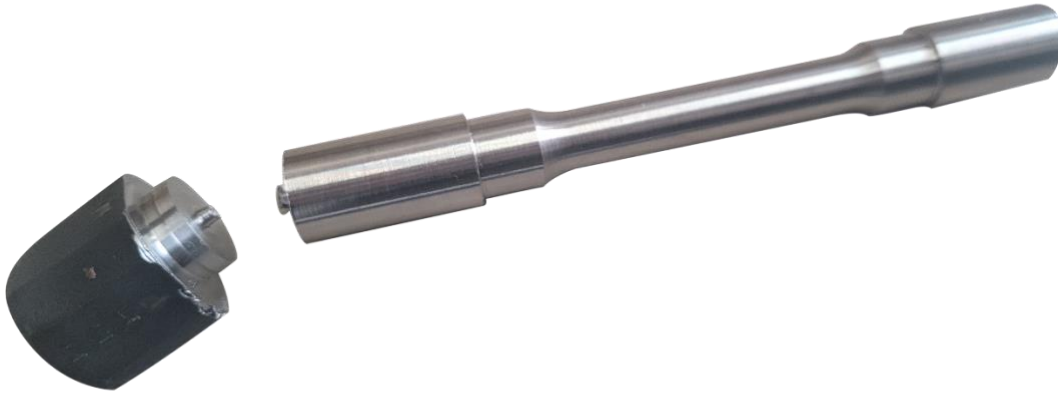
N200 UNS N02200 – <55 HRB
