Machine Used: TensileTurn – Industrial Upgrade Model

## Machined Specimens:

## Machining Conditions:

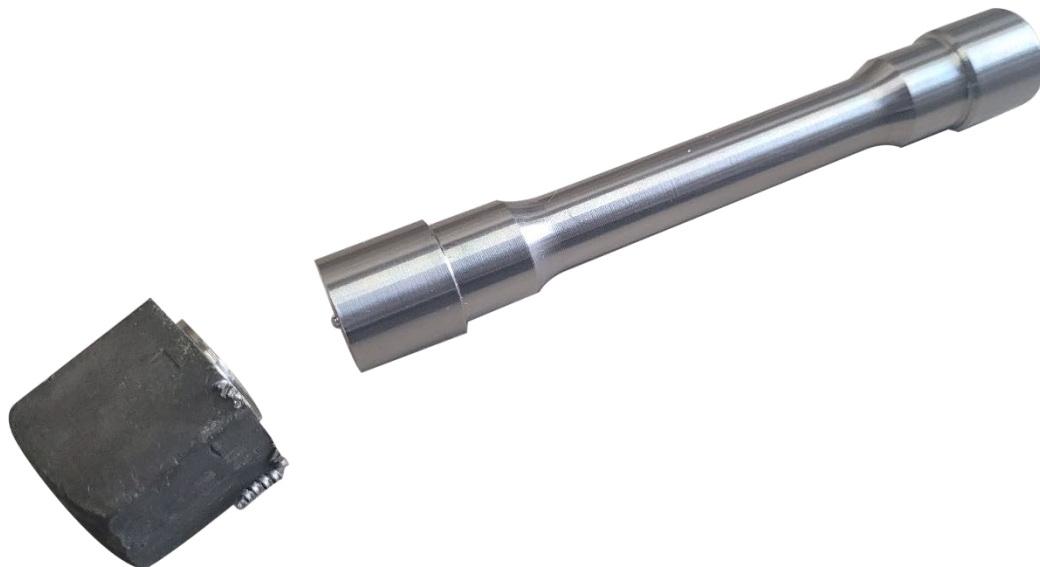
C276 UNS N10276 – 90 HRB

- Due to the irregular shapes and material characteristics, interrupted cutting occurs frequently. A high-quality insert suitable for interrupted cutting is highly recommended.
- The machining parameters used reflect standard test conditions. However, customers are encouraged to optimize feeds, speeds, and tooling for continuous production, based on their expertise and specific performance goals.

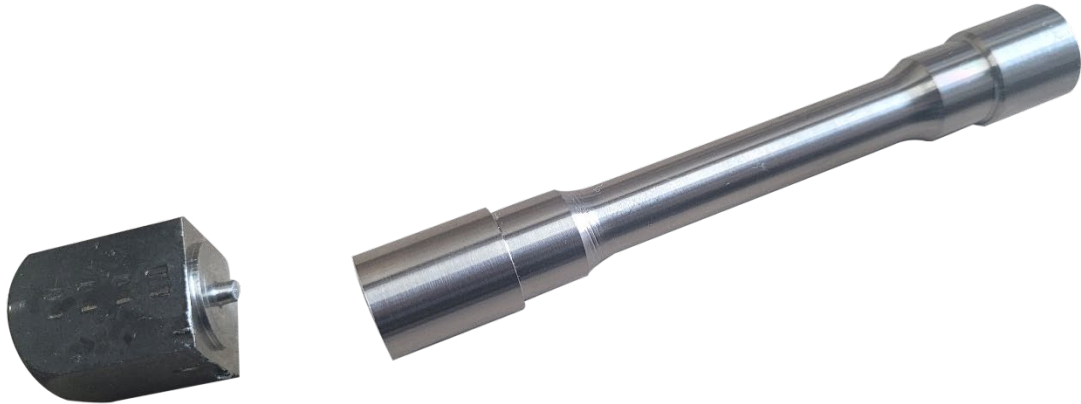
A625 UNS N06625 – 98 HRB

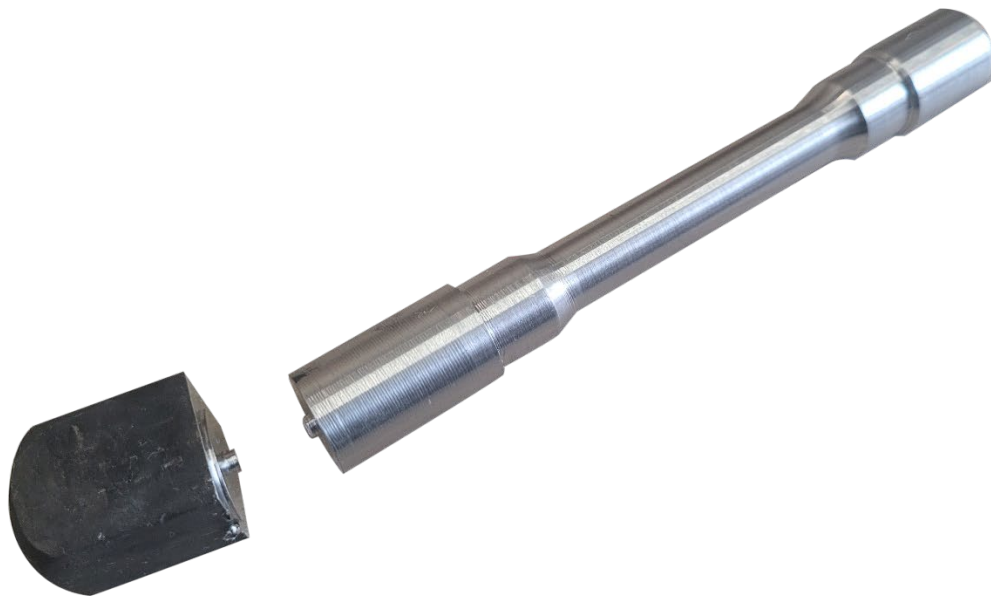
A600 UNS N06600 – 88 HRB

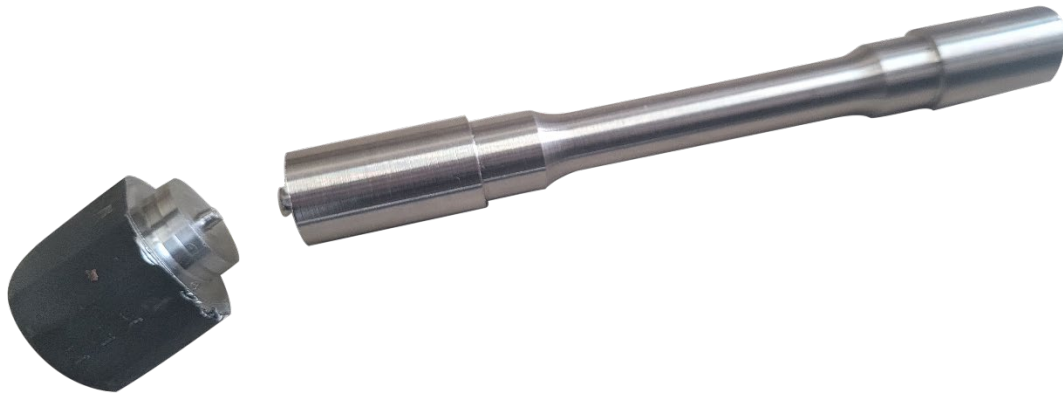
N200 UNS N02200 – <55 HRB
