Machine Used: TensileTurn – Industrial Upgrade Model

Machining Conditions:

Turning Operations:

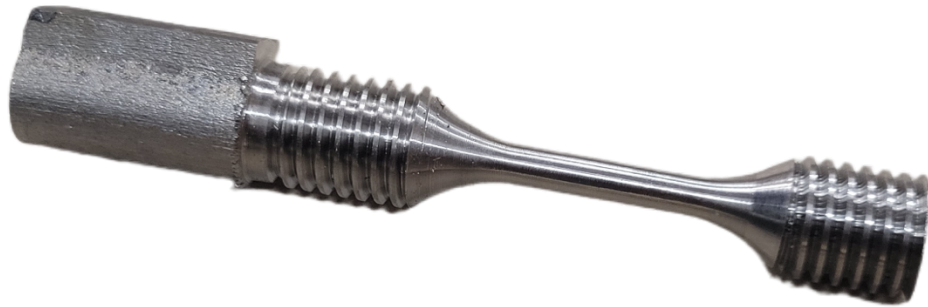
Non-Treated 718 Parts:

- **Surface Speed (SFM):** 45 meters/minute
- **Feed per Revolution:** 0.15 mm/rev
- **Depth of Cut:** 0.5 mm per radial pass
- **Cycle Time:** 3 minutes
- **Videos:**

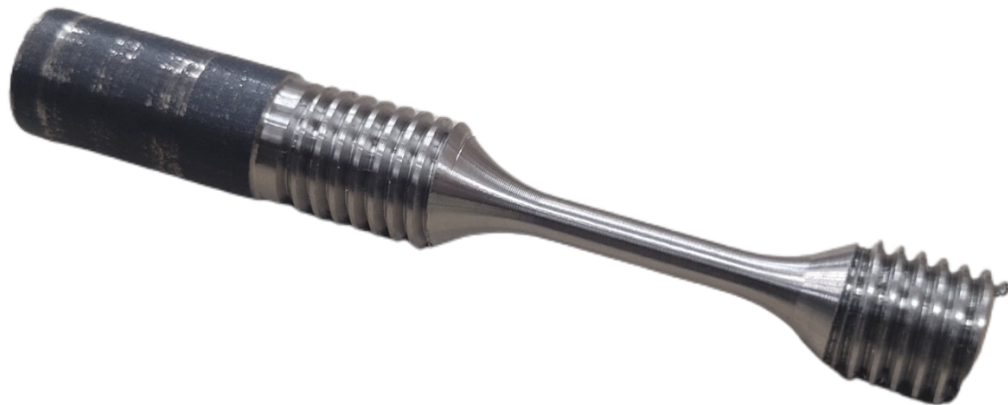
**718 Heat Treated Parts:**

- **Surface Speed (SFM):** 22 meters/minute
- **Feed per Revolution:** 0.15 mm/rev
- **Depth of Cut:** 0.25 mm per radial pass
- **Cycle Time:** 6 minutes
- **Videos:**
 - [REDACTED]
 - [REDACTED]

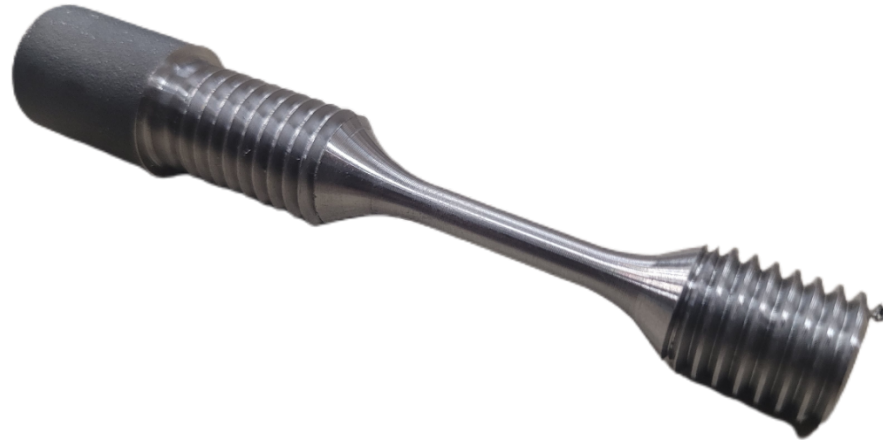
**W722 Heat Treated – Piece 1:**

- **Surface Speed (SFM):** 22 meters/minute
- **Feed per Revolution:** 0.15 mm/rev
- **Depth of Cut:** 0.25 mm per radial pass
- **Cycle Time:** 6 minutes
- **Video:** [REDACTED]

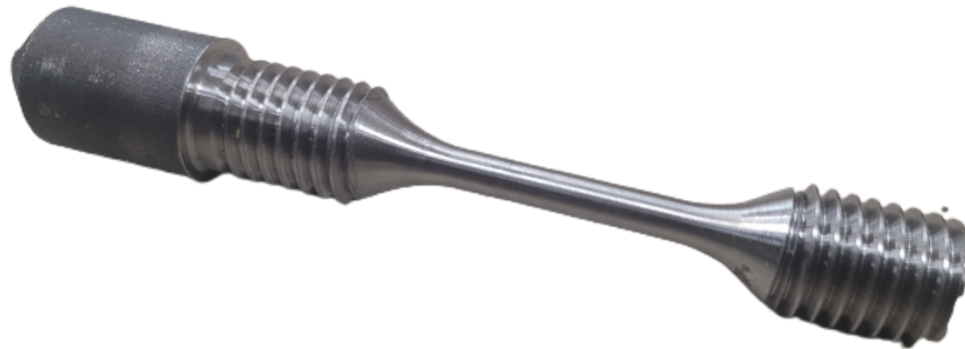
**W722 Heat Treated – Piece 2:**

- **Surface Speed (SFM):** 22 meters/minute
- **Feed per Revolution:** 0.15 mm/rev
- **Depth of Cut:** 0.25 mm per radial pass
- **Cycle Time:** 6 minutes
- **Video:** [REDACTED]
