Machine Used: TensileTurn – Industrial Upgrade Model

Machining Conditions:

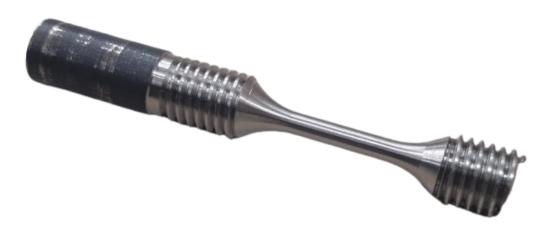
718 Heat Treated Parts:

- Surface Speed (SFM): 22 meters/minute
- Feed per Revolution: 0.15 mm/rev
- **Depth of Cut:** 0.25 mm per radial pass
- Cycle Time: 6 minutes
- Videos:

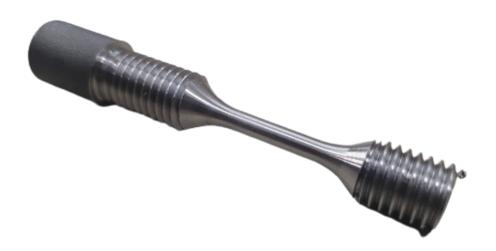
W722 Heat Treated - Piece 1:

- Surface Speed (SFM): 22 meters/minute
- Feed per Revolution: 0.15 mm/rev
- **Depth of Cut:** 0.25 mm per radial pass
- Cycle Time: 6 minutes
- Video:

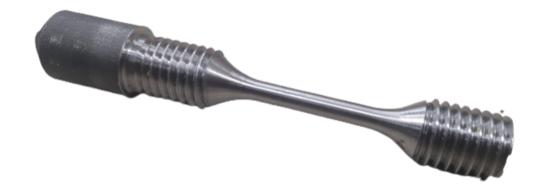
W722 Heat Treated - Piece 2:

- Surface Speed (SFM): 22 meters/minute
- Feed per Revolution: 0.15 mm/rev
- Depth of Cut: 0.25 mm per radial pass
- Cycle Time: 6 minutes
- Video:
