Customer:
Machine Used: TensileTurn – Industrial Upgrade Model
Date:
Prepared By:

SAMPLE PARTS MACHINING REPORT

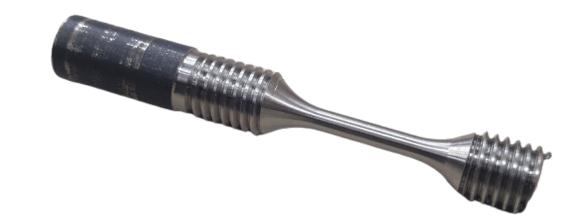
718 Heat Treated Parts:

- Surface Speed (SFM): 22 meters/minute
- Feed per Revolution: 0.15 mm/rev
- Depth of Cut: 0.25 mm per radial pass
- Cycle Time: 6 minutes
- Videos:

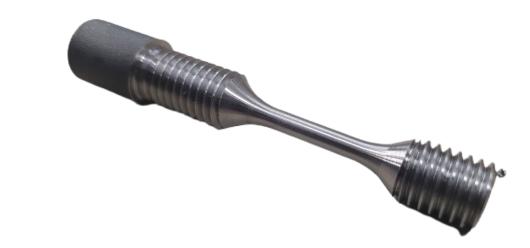
W722 Heat Treated – Piece 1:

- Surface Speed (SFM): 22 meters/minute
- Feed per Revolution: 0.15 mm/rev
- Depth of Cut: 0.25 mm per radial pass
- Cycle Time: 6 minutes
- Video:

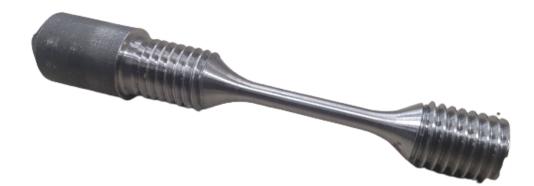
W722 Heat Treated – Piece 2:

- Surface Speed (SFM): 22 meters/minute
- Feed per Revolution: 0.15 mm/rev
- Depth of Cut: 0.25 mm per radial pass
- Cycle Time: 6 minutes
- Video:
